WIMBA®

Case Study:

Carpal Ligament injury

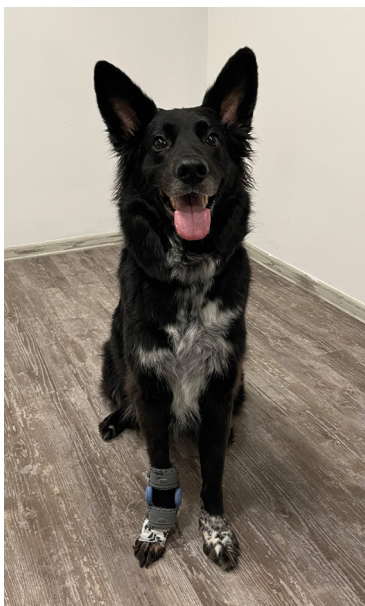
Medical Condition: Damaged medial dorsal ligament between the radial carpal bone and the 1st and 2nd carpal bones.

Subluxation of the medial carpal joint with medial instability, without carpal hyperextension.

Reconstruction and stabilization of the medial compartment between the radial carpal bone and the medial-radial carpal bones I and II (Ligafibe 150 LB) + orthosis during post-operative rehabilitation.

orthosis was blocked during the first stage of rehabilitation. After 3 weeks, the token in the orthosis was changed to a token with a physiological range of movement. No skin problems related to abrasions were noticed during the use of the orthosis.
